# TSC

## SUBSEA

Solving the most challenging subsea inspections –  
from the routine to the seemingly impossible.

**Deck Launched,  
Robotic Crawler for  
In-Service Hull  
Inspections.**

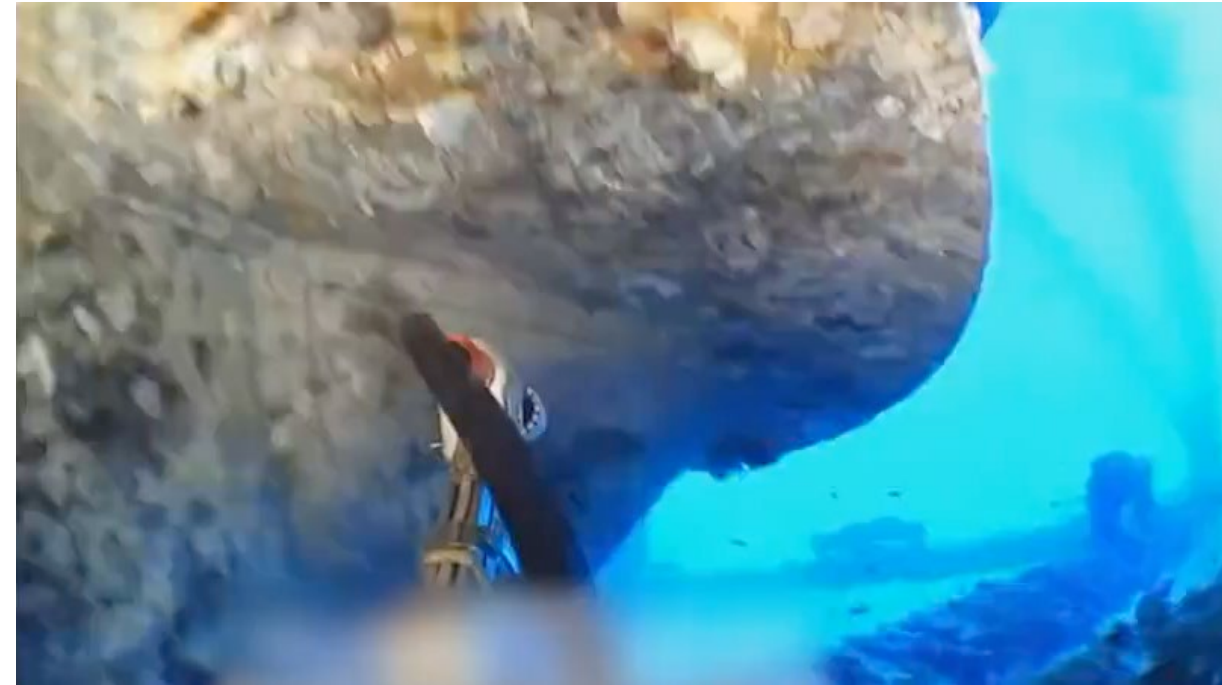
Eddy Current (EC) probe deployment using an ROV manipulator

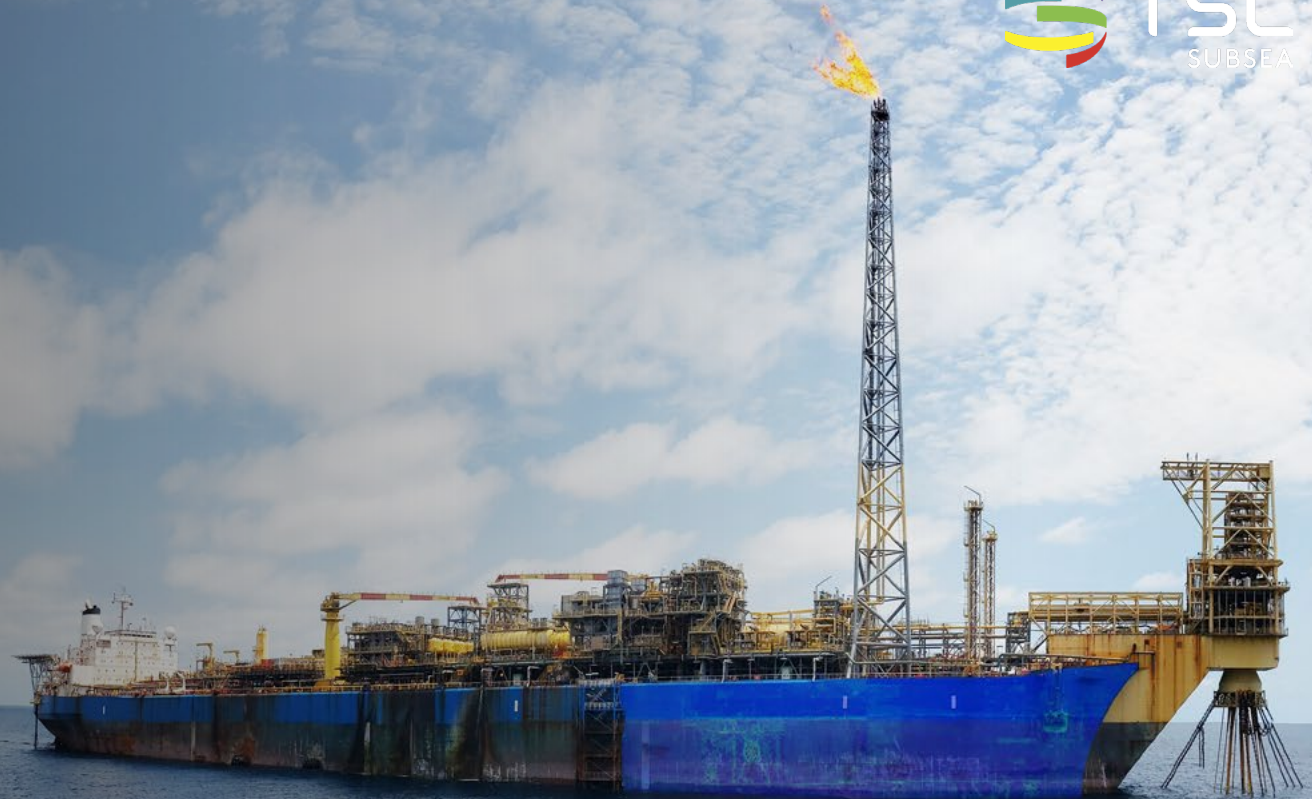
Delivering complete wall thickness and corrosion maps with sub-millimetre accuracy.

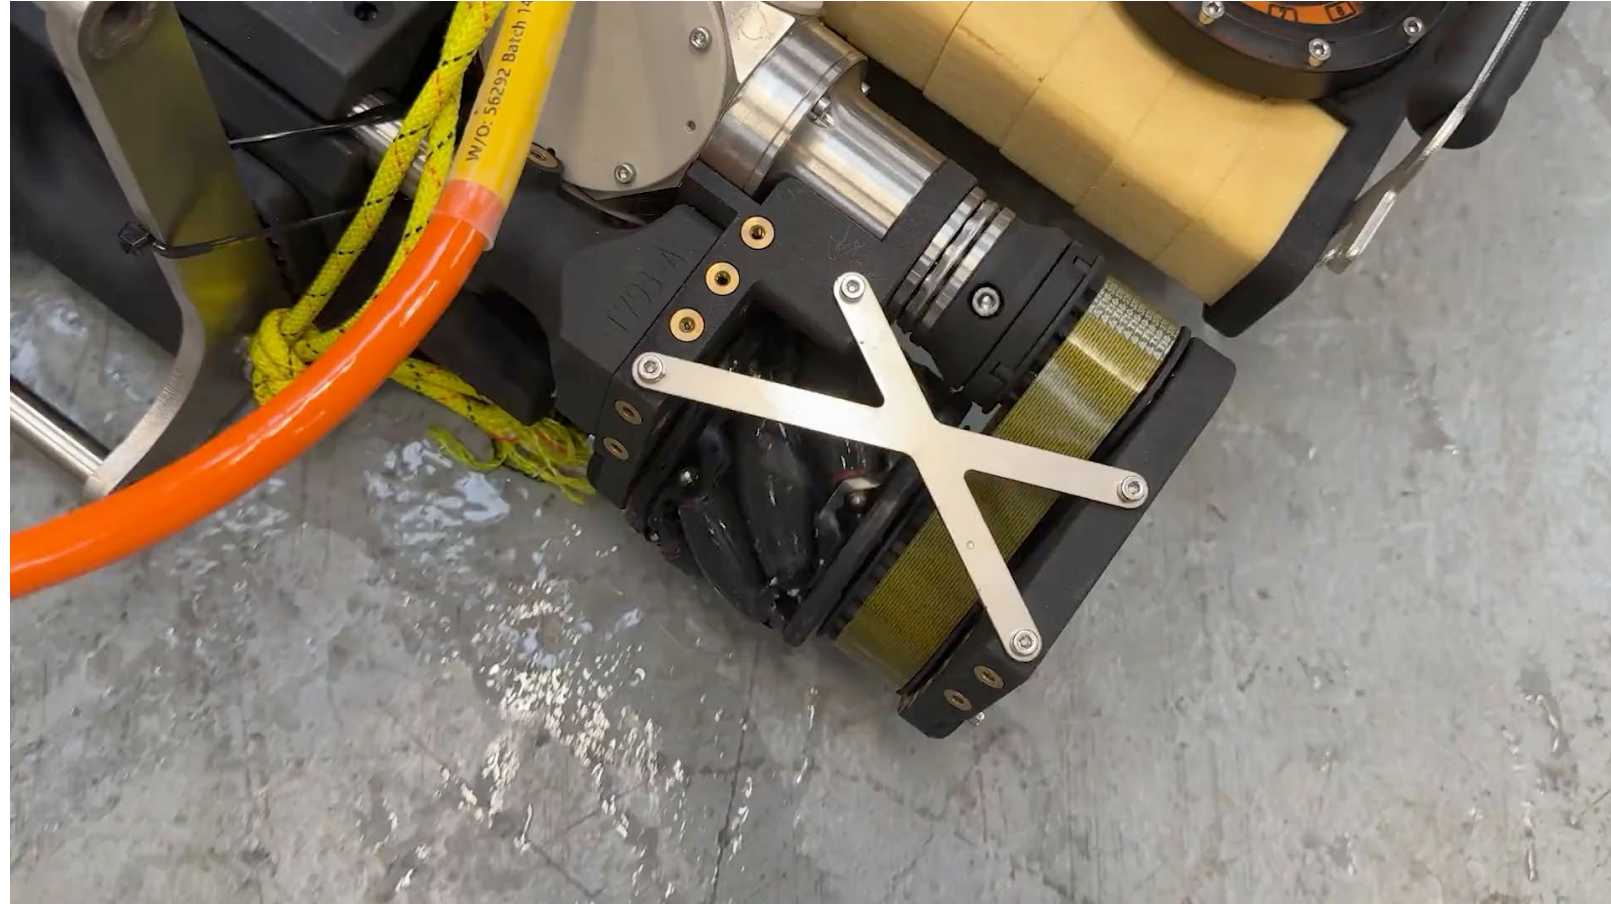
- Drive forward/backward, sideways left/right and turn on the spot.
- Efficiently navigates large and complex surfaces.
- Distance-tracking motors with encoders.
- Optimises scan patterns for maximum coverage.
- Exceptional manoeuvrability around obstacles.

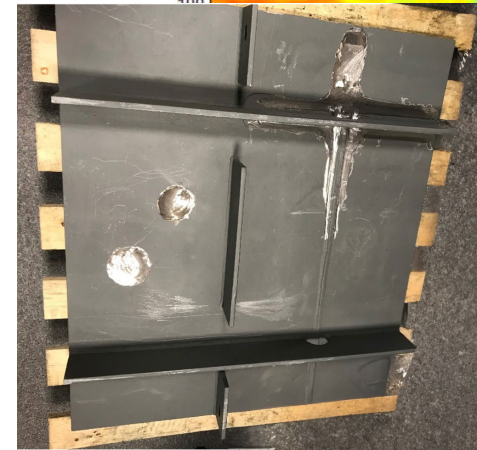
Scan conducted from the opposite side of the test plate.

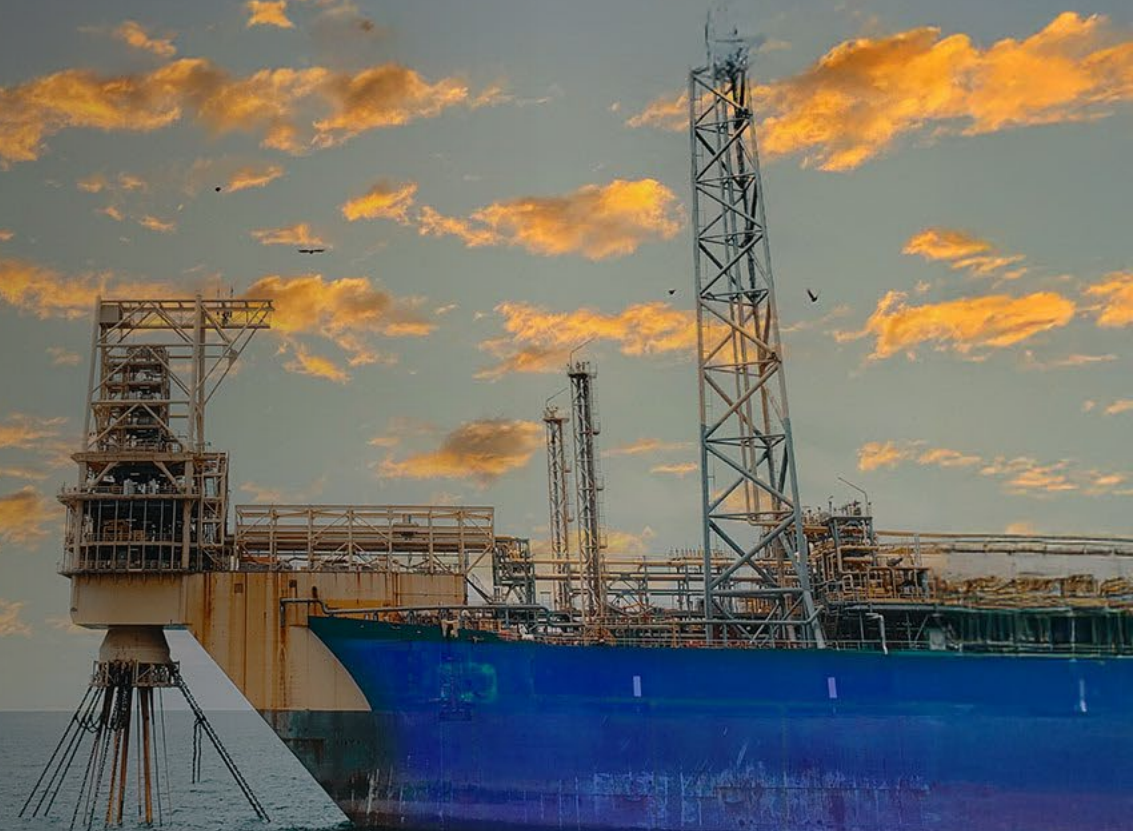
- **Objective:** To gain validation from Lloyd's Register for Hull Plate thickness inspection.
- **Task:** Conduct an **Acoustic Resonance Technology (ART)** corrosion mapping inspection of an FPSO single skin test sample (owned by HITS JIP).
- **Why:** Requested by major FPSO operators and several naval forces.
- **Location:** Forth Engineering, Flimby, UK.
- **Benchmark:** Phased Array Ultrasonics (PAUT) for accuracy comparison. PAUT is widely recognised as one of the most reliable methods for quantitative wall thickness measurement.

*Application of Acoustic Resonance Technology (ART) to perform quantitative Ultrasonic Thickness Measurement (UTM) for both internal and external corrosion defects of ship hull carbon steel plate through coating.*

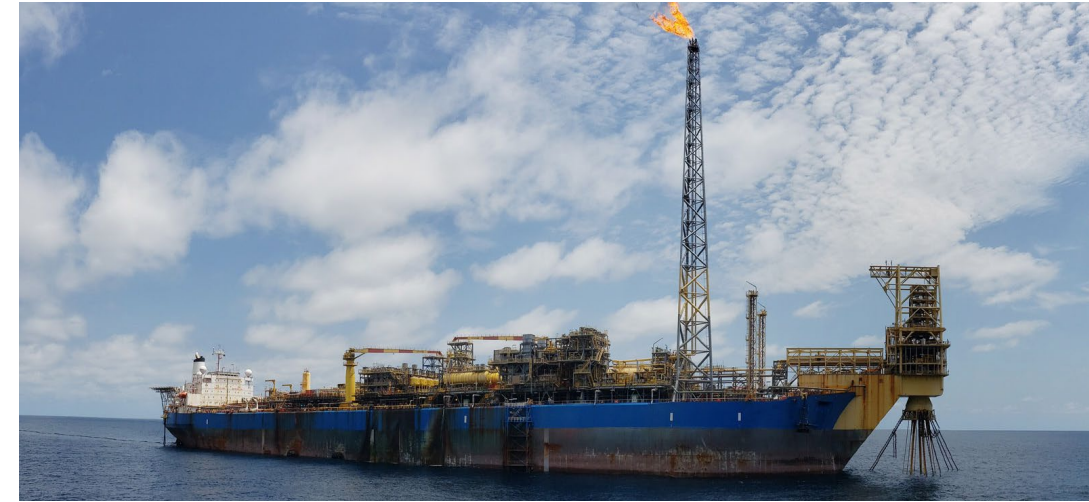
Area of interest

Underside of hull

- Built in 1981 as a single-skinned tanker, converted to FPSO in 2008.
- Operating under a Risk-Based Inspection (RBI) regime.
- Area below the engine/pump room was not accessible for internal inspection.
- Required diverless in-water inspection without stopping production operations.

- Accurately map and size external hull defects >1 mm.
- Overcome subsea issues: currents, swell, marine growth.

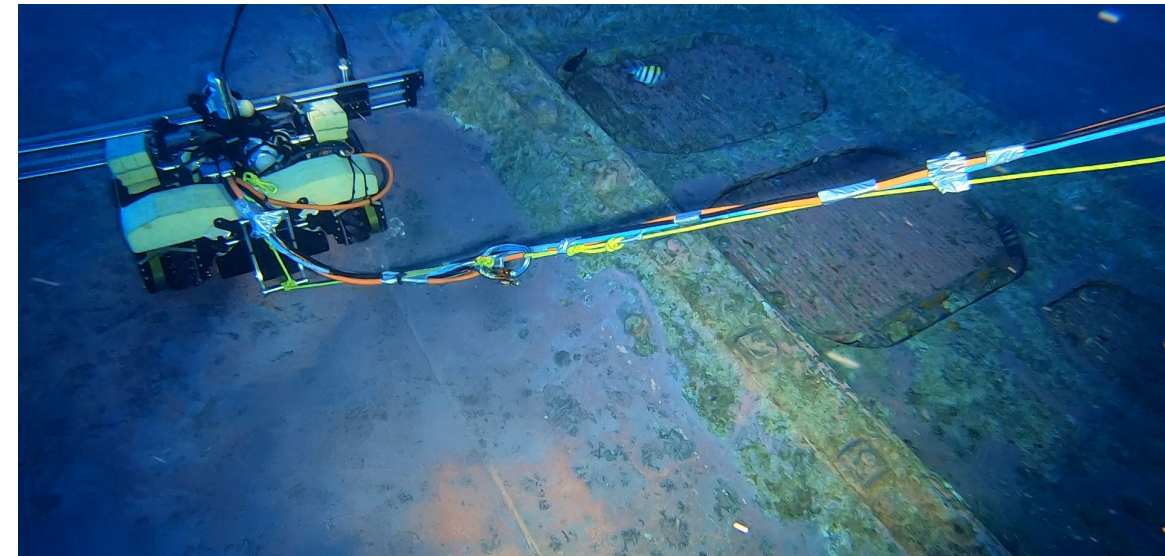
- ORCA: deck-launched, omnidirectional robotic crawler.
- Acoustic Resonance Technology (ART) delivering sub-mm thickness accuracy.
- Adjustable resolution ranging from 25 x 25 mm for high-speed scanning and 25 x 1mm for higher resolution.

- Detailed corrosion mapping generated from stitched scan data.
- Verified hull integrity with no critical wall loss.
- No production loss, no divers, no support vessels.
