# ECA on Carbon Steel weld in lieu of PT

KINT - Samenwerken aan de  
kwaliteit van Inspectie en NDO

Congres 15/04/2026

Van Eesbeeck Wouter – ET LIII NDT Expert  
Engie Laborelec

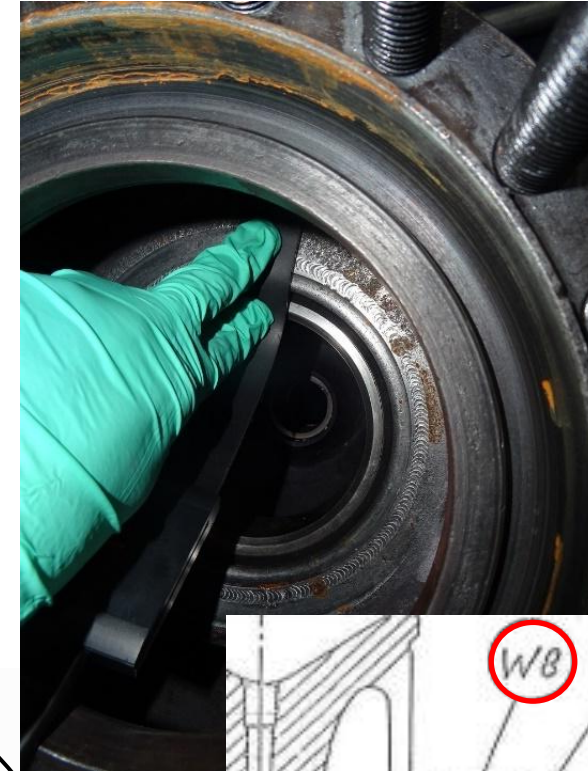
## Various challenges were faced

- Short notice intervention prior to start-up
- First of a kind → no procedures available (= expertise mode)
- Lack of reference pieces – transversal flaw orientation
- Geometry
  - Limited accessibility
  - 360° manual scanning
  - Curved surface

Data acquired successfully

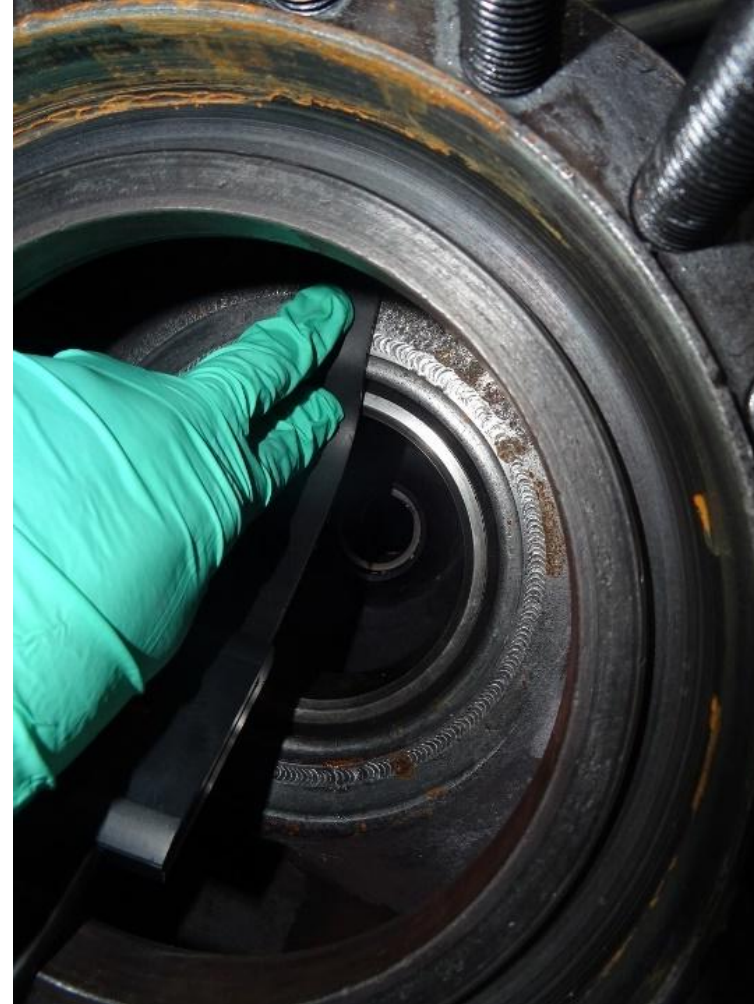
- Tests of 2022 were repeated
- Additional setups were tested
- Geometry
  - Limited accessibility
  - Curved surface
  - 360° manual scanning

**Comparable data acquired +  
new ECA insights obtained**

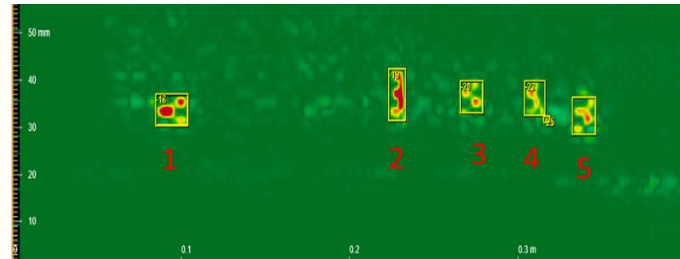
## Region 1 - ECA proves increased resolution (flaw 2)

- Flaw detected and characterized as linear during both outages
- No growth evolution observed
- In 2024 ECA HR SDD revealed a discontinued indication

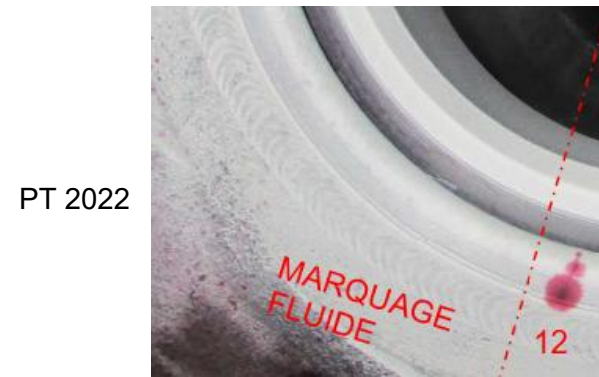
## Region 3 - ECA demonstrates enhanced sensitivity (Flaws 12, 16 & 17 )

- **PT:**
  - 1 flaw reported in 2022
  - 1 new flaw appeared over time
  - Flaw 12 seems to evolve over time

- **ECA:**
  - 2 flaws reported in 2022
  - 3 flaws reported in 2024
  - Flaw 12 remained stable over time
